#### Routes to a Reliable K Series Engine

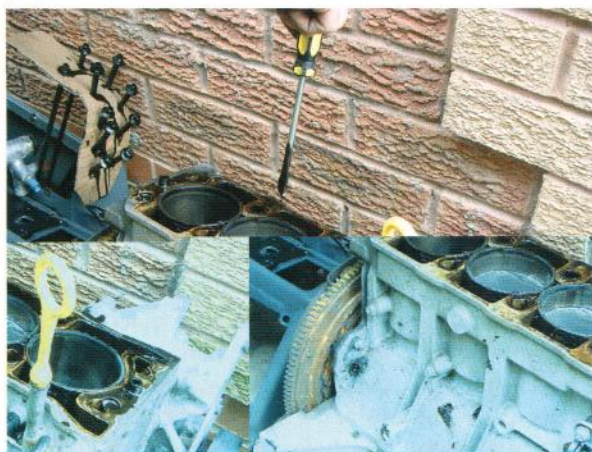
Fig. 4.31 When HGF is allowed to develop to the point where the engine stops, the coolant turns to a light tar.

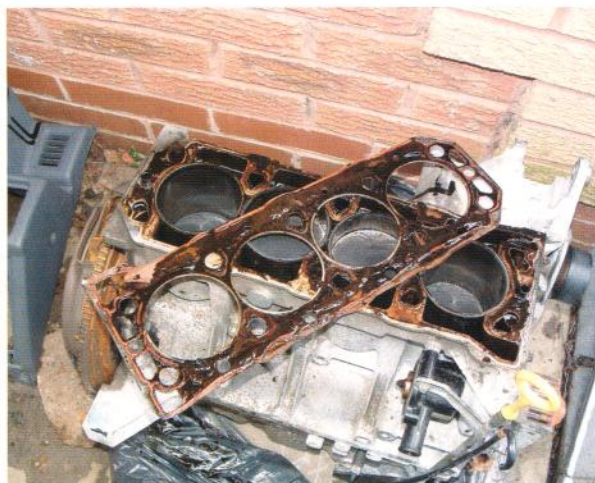
Fig. 4.32 The head gasket becomes a gooey mess.

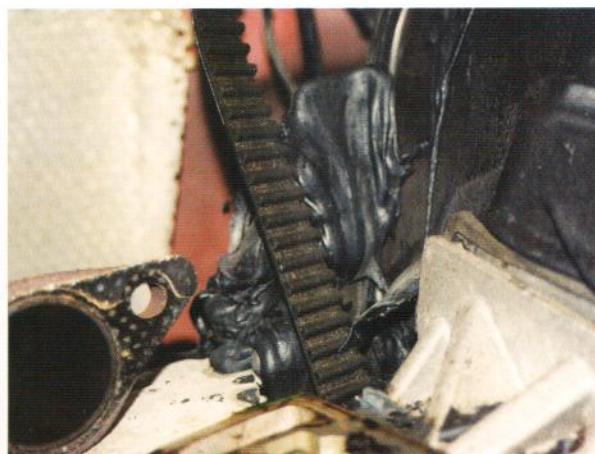
Fig. 4.34 This engine was run until it just stopped and all the plastics started to melt, with the cam cover reduced to a blob.

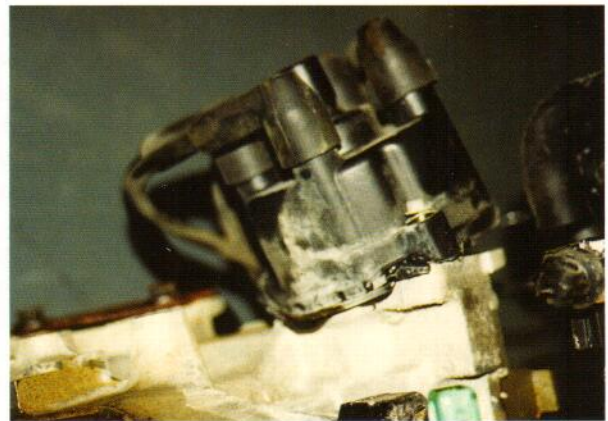
Fig. 4.36 The distributor cap was well on the way to joining the cam covers.

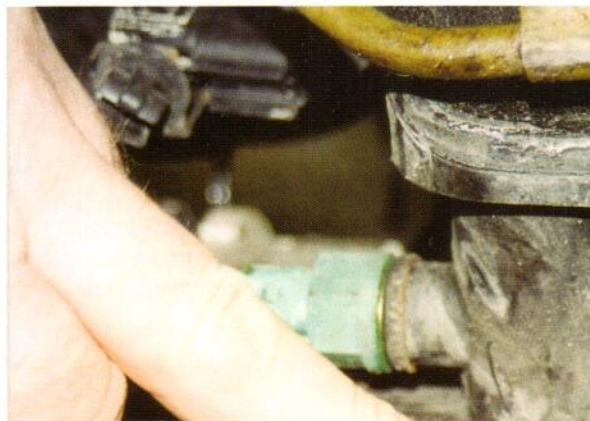
Fig. 4.37 Surprisingly, though, the plastic inlet manifold was just melting at the join onto the cylinder head.

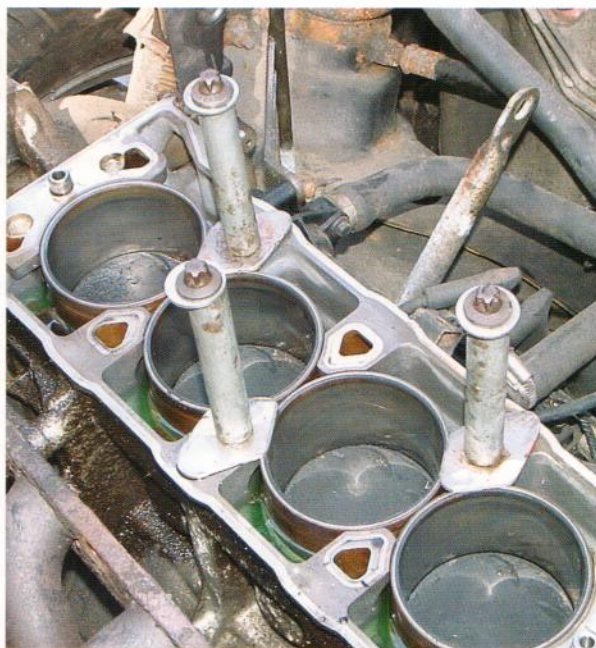
TOP RIGHT: Fig. 4.72 A simple alternative to liner clamps can be made from steel tube and a series of washers.

Do not turn the engine over unless you have first fitted the specific liner clamping tools, or made ones up yourself from tubing and larger flat washers, otherwise the care taken to remove the head without disturbing a liner will probably be undone as the piston movement upwards will lift the liner as well. Home-made ones need not have the shaped feet, just strong flat washers that are able to cover the tops of adjacent liners with a tube length of approximately 110mm.

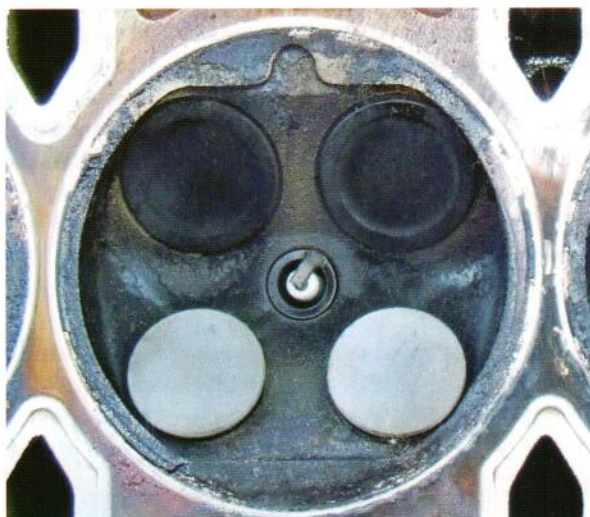
Fig. 4.75 Valves are close to the head face that restricts the maximum skim limit and on this MPI head with small valves there is more scope for skimming.

Finally, on the skimming front are the practical restrictions that apply to VVC engines, as their valves are so much closer to the head face. As a result their practical skim limit is far less than an

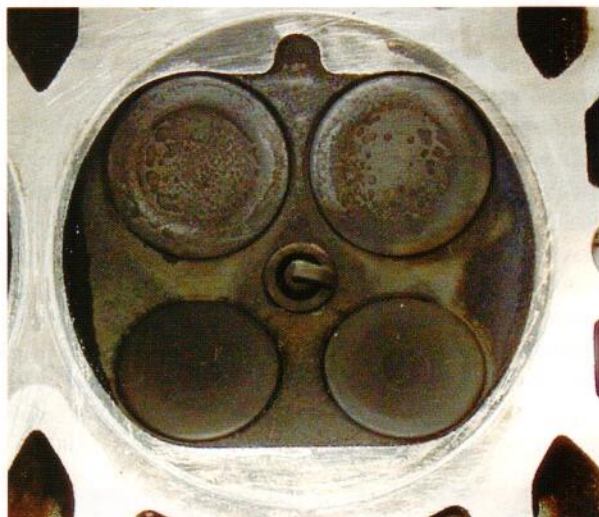
Fig. 4.76 On VVC heads, where the bigger valves are much closer to the head face, skimming is more of a problem.

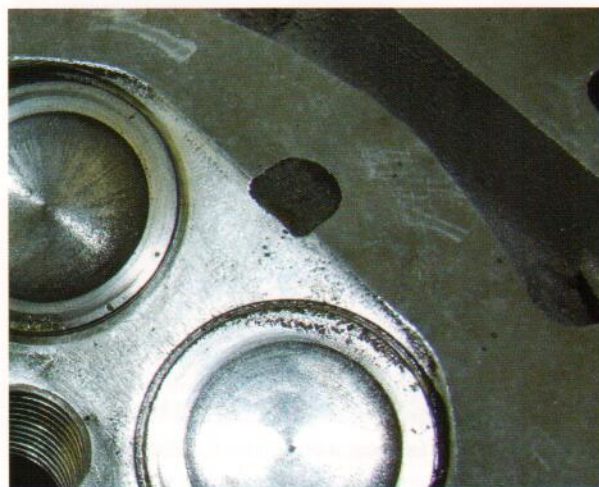
Fig. 4.78 A skimmed head looks like this. Some heads may even have seen the dimple completely skimmed away.
